**Flood Control Project Maintenance
Levee Inspections**
LMA District Cover Sheet
Spring 2011 Levee Inspection Results

American River Flood Control District

Spring 2011 Levee Inspection Results

Levee Inspection Report By Mile - Spring 2011

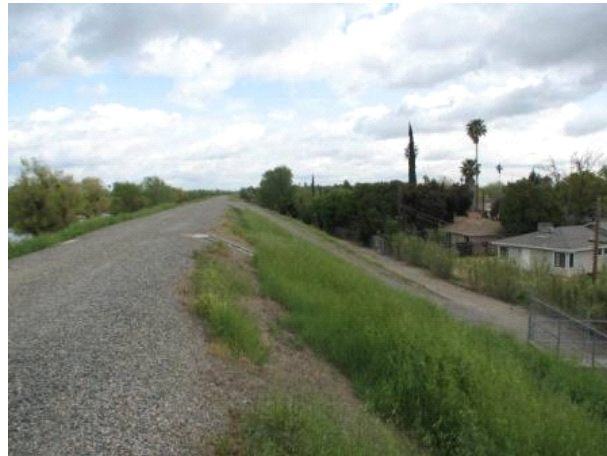
Levee Mile Report Line	1
Start Levee Mile	0.04
End Levee Mile	0.67
Location	Land Side
Category	Earthen Levee
Item	Vegetation
04/13/2011 Mowing has not been started on this unit.	
jeto_s_20110413_392.jpg

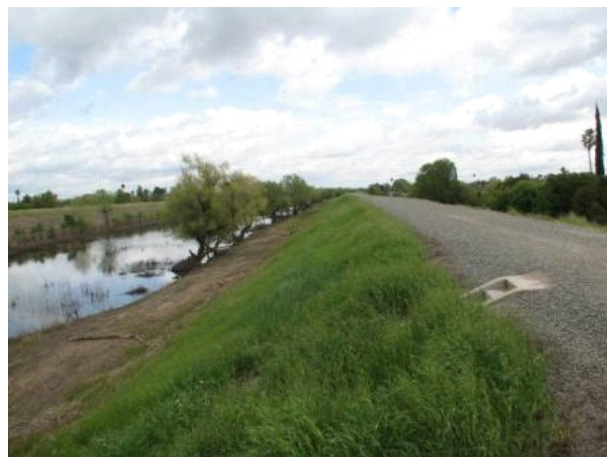
Levee Mile Report Line	2
Start Levee Mile	0.04
End Levee Mile	0.67
Location	Water Side
Category	Earthen Levee
Item	Vegetation
04/13/2011 Mowing for this unit has not yet started.	
jeto_s_20110413_391.jpg

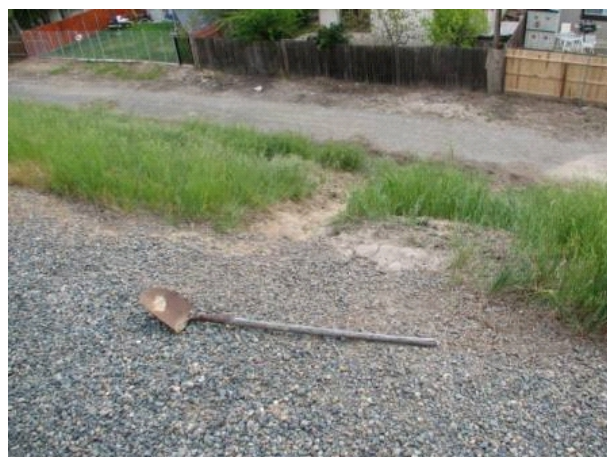
Levee Mile Report Line	3
Start Levee Mile	0.22
End Levee Mile	0.22
Location	Land Side
Category	Earthen Levee
Item	Slope Stability
04/13/2011 Appears as though steps have been cut into the levee. Need to be filled and recompact.	
jeto_s_20110413_393.jpg

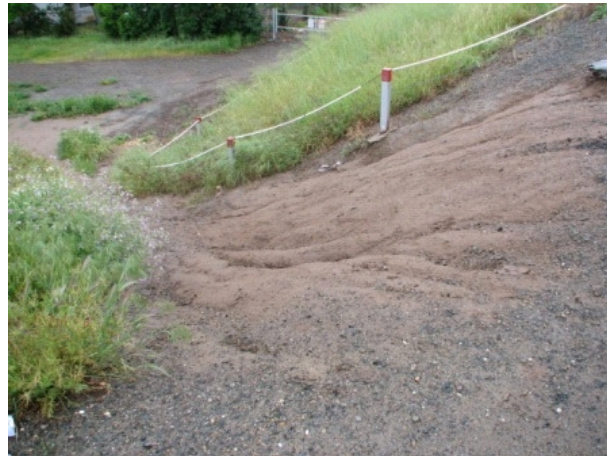
jeto_s_20110301_305.jpg

Slope erosion due in part to foot traffic needs to be monitored. Repair will be needed if condition worsens.

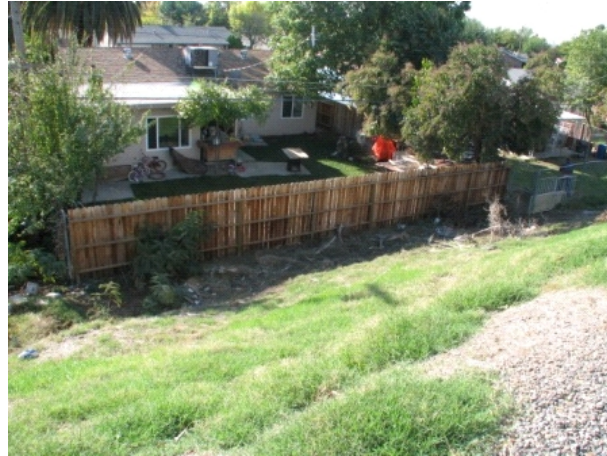
Levee Mile Report Line	8
Start Levee Mile	0.72
End Levee Mile	0.72
Location	Land Side
Category	Earthen Levee
Item	Encroachments
Fall 2009 photo: Wooden fence within 10-ft of levee toe obstructs visibility.	
jeto_s_20110301_301.jpg

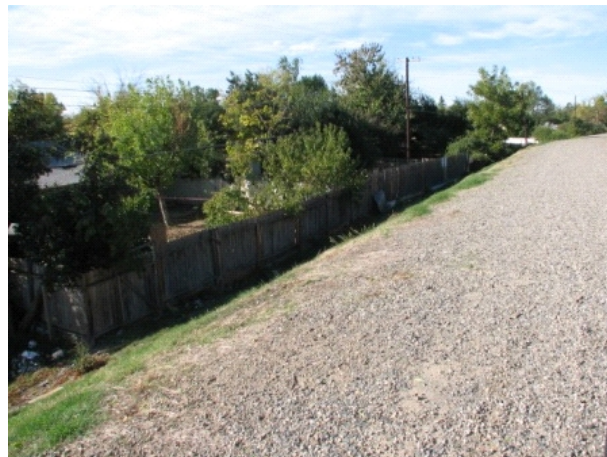
Levee Mile Report Line	12
Start Levee Mile	1.19
End Levee Mile	1.19
Location	Land Side
Category	Earthen Levee
Item	Encroachments
Photo of solid fences built against the levee slope.	
jeto_s_20110301_298.jpg

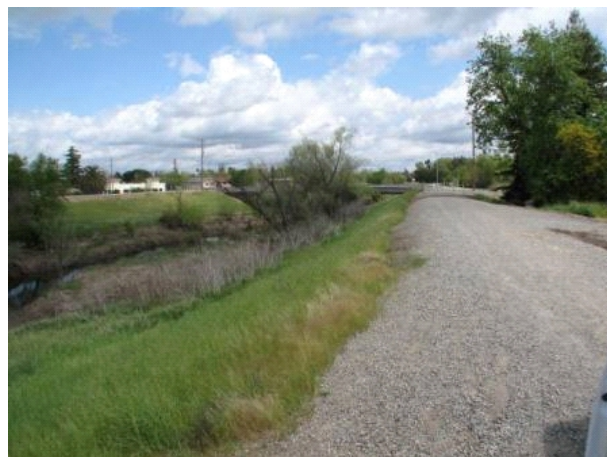
Levee Mile Report Line	13
Start Levee Mile	1.22
End Levee Mile	1.26
Location	Water Side
Category	Earthen Levee
Item	Vegetation
04/13/2011 Mowing has not started in this unit.	
jeto_s_20110413_396.jpg

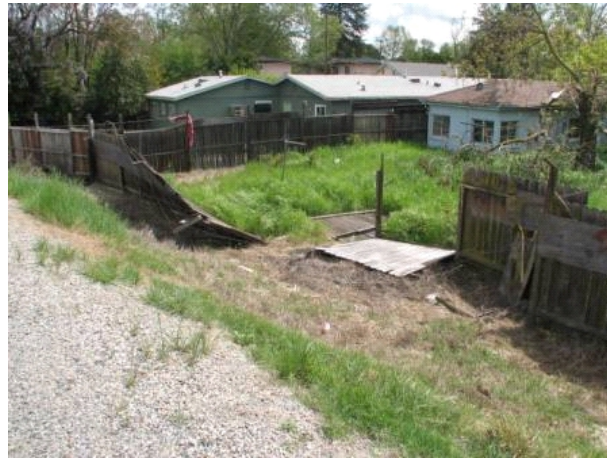
Levee Mile Report Line	23
Start Levee Mile	1.41
End Levee Mile	1.41
Location	Land Side
Category	Earthen Levee
Item	Encroachments
04/13/2011 Fence has fallen down, now encroaches farther onto the levee.	
jeto_s_20110413_399.jpg

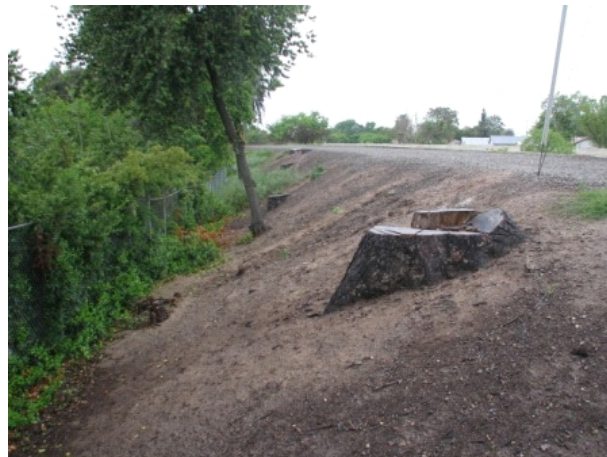
Levee Mile Report Line	25
Start Levee Mile	1.52
End Levee Mile	1.52
Location	Land Side
Category	Earthen Levee
Item	Trim / Thin Trees
Several large stumps on levee slope.	
jeto_s_20110301_304.jpg

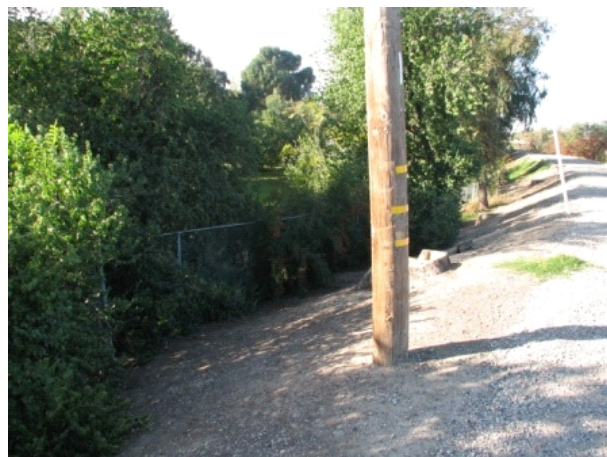
Levee Mile Report Line	26
Start Levee Mile	1.54
End Levee Mile	1.54
Location	Land Side
Category	Earthen Levee
Item	Encroachments
Fall 2009 photo:Vegetation obstructing visibility near levee slope.	
jeto_s_20110301_299.jpg

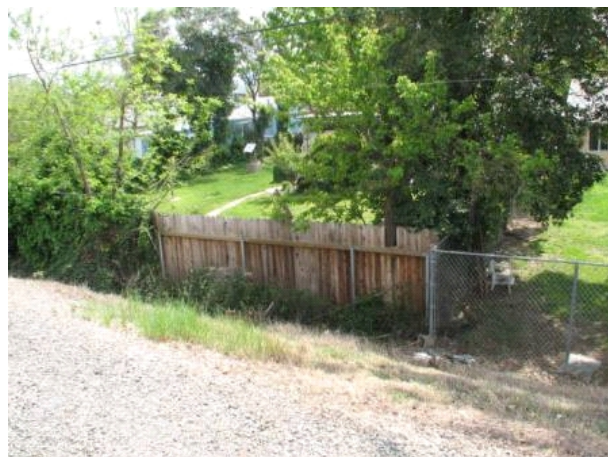
jeto_s_20110413_404.jpg

Levee Mile Report Line	34
Start Levee Mile	1.83
End Levee Mile	1.83
Location	Land Side
Category	Earthen Levee
Item	Encroachments

04/13/2011 Portion of fence has been replaced, assume that this is the portion that fell down and was referenced in the fall '10 inspection.

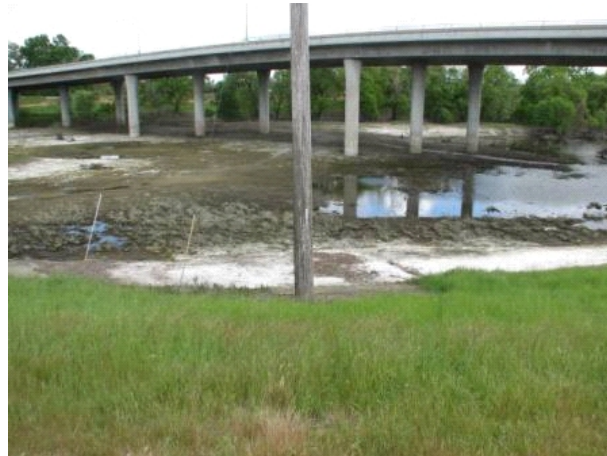
Levee Mile Report Line	1
Start Levee Mile	0.28
End Levee Mile	0.28
Location	Water Side
Category	Earthen Levee
Item	Encroachments
04/13/2011 Power pole is in the levee on the water side.	
jeto_s_20110413_389.jpg

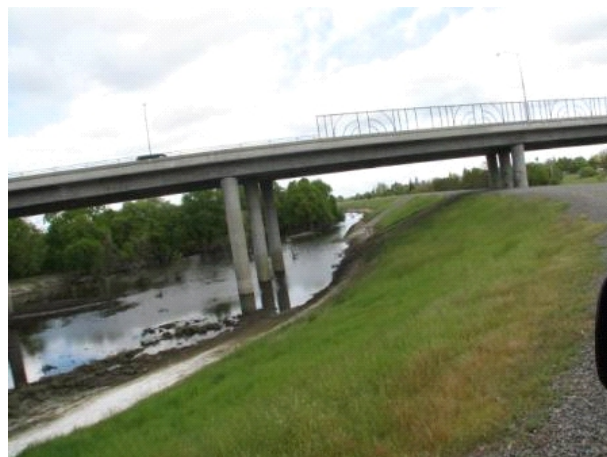
Levee Mile Report Line	2
Start Levee Mile	0.28
End Levee Mile	1.15
Location	Land Side
Category	Earthen Levee
Item	Vegetation
04/13/2011 Mowing has not yet started in this unit.	
jeto_s_20110413_413.jpg

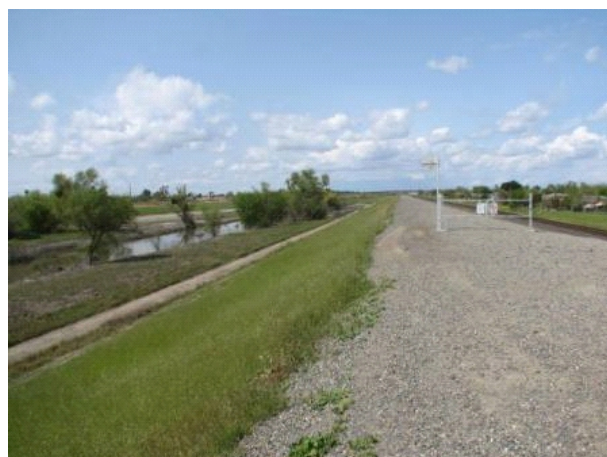
Levee Mile Report Line	4
Start Levee Mile	1.37
End Levee Mile	3.92
Location	Water Side
Category	Earthen Levee
Item	Vegetation
04/13/2011 Mowing has not yet started in this unit.	
jeto_s_20110413_412.jpg

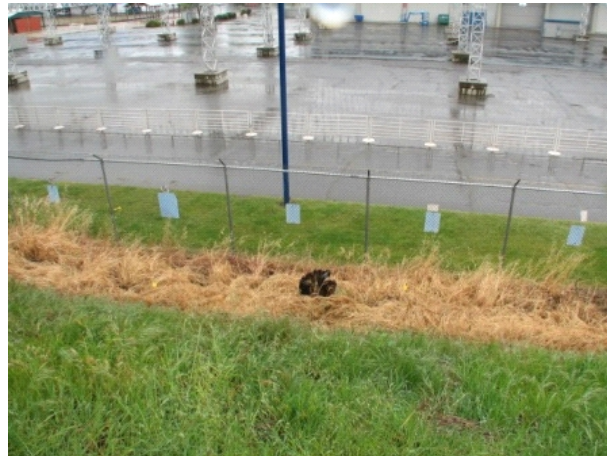
Levee Mile Report Line	1
Start Levee Mile	0.76
End Levee Mile	0.76
Location	Land Side
Category	Earthen Levee
Item	Trim / Thin Trees
Tree stump on levee slope greater than 2" Dia.	
jeto_s_20110301_307.jpg

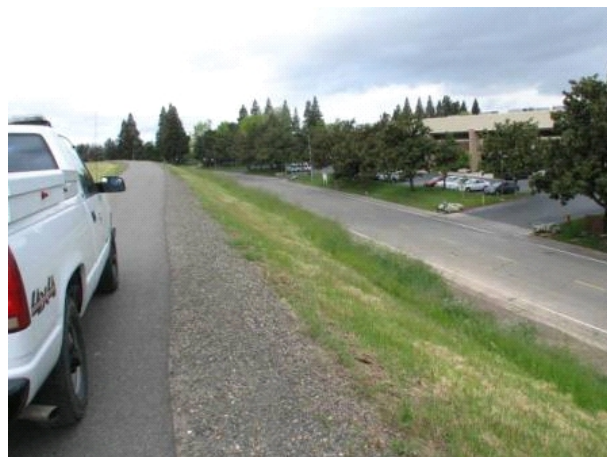
Levee Mile Report Line	2
Start Levee Mile	1.63
End Levee Mile	1.80
Location	Land Side
Category	Earthen Levee
Item	Vegetation
04/13/2011 Landside weeds are mowed high and low, need to be mowed at middle height.	
jeto_s_20110413_387.jpg

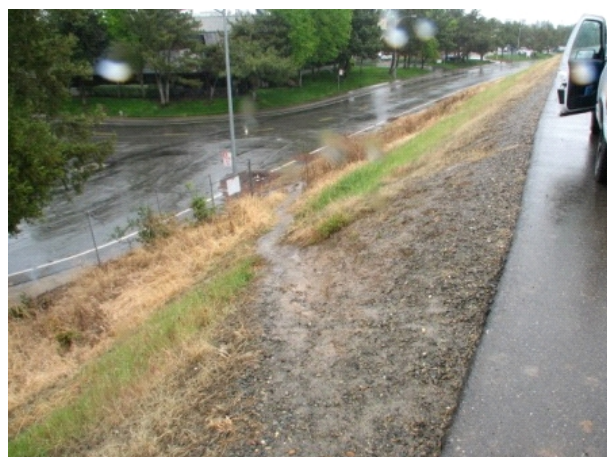
Levee Mile Report Line	3
Start Levee Mile	1.80
End Levee Mile	1.80
Location	Land Side
Category	Earthen Levee
Item	Slope Stability
Slope needs to be monitored due to heavy foot traffic.	
jeto_s_20110301_306.jpg

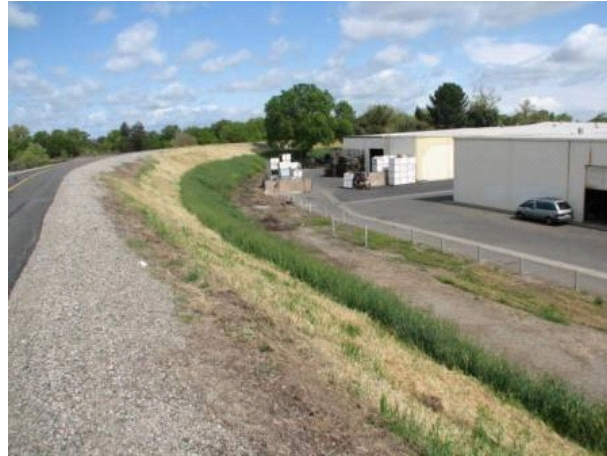
Levee Mile Report Line	6
Start Levee Mile	3.26
End Levee Mile	3.34
Location	Land Side
Category	Earthen Levee
Item	Vegetation
04/13/2011 Mowing needs to be completed on land side.	
jeto_s_20110413_388.jpg

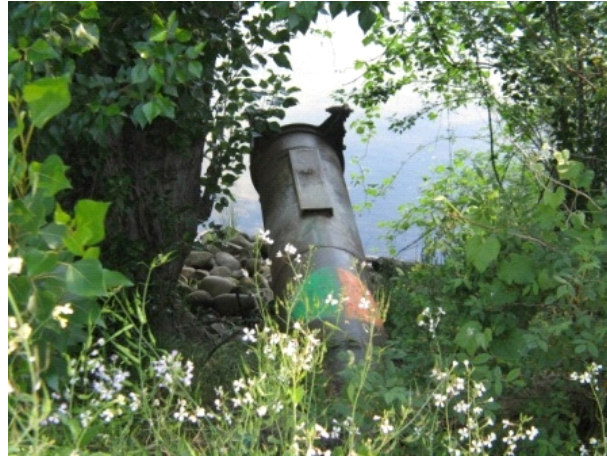
Levee Mile Report Line	6
Start Levee Mile	0.94
End Levee Mile	0.94
Location	Crown
Category	Earthen Levee
Item	Encroachments
Discharge pipe from printing shop into American River.	
jeto_s_20110301_313.jpg

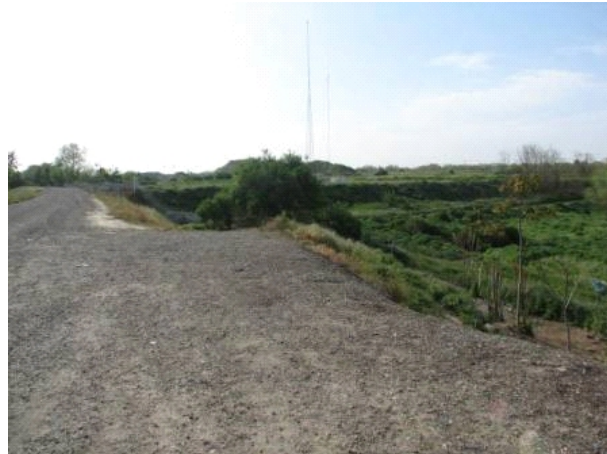
Levee Mile Report Line	8
Start Levee Mile	2.45
End Levee Mile	2.45
Location	Land Side
Category	Earthen Levee
Item	Vegetation
04/14/2011 Elderberry bush prevents visibility of levee toe.	
jeto_s_20110414_416.jpg

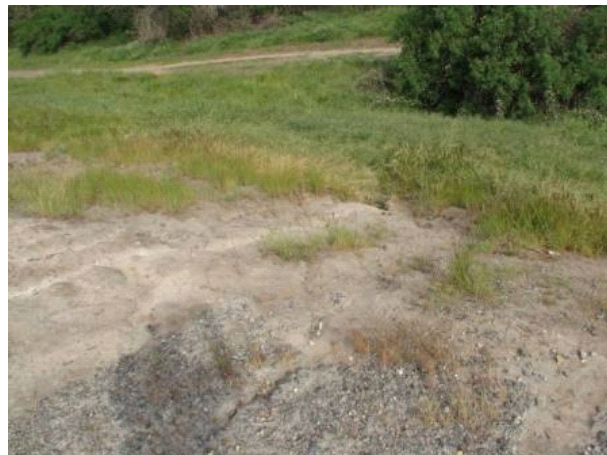
Levee Mile Report Line	15
Start Levee Mile	2.99
End Levee Mile	2.99
Location	Crown
Category	Earthen Levee
Item	Erosion / Bank Caving
04/14/2011 Erosion caused by runoff from adjacent parking lot.	
jeto_s_20110414_417.jpg

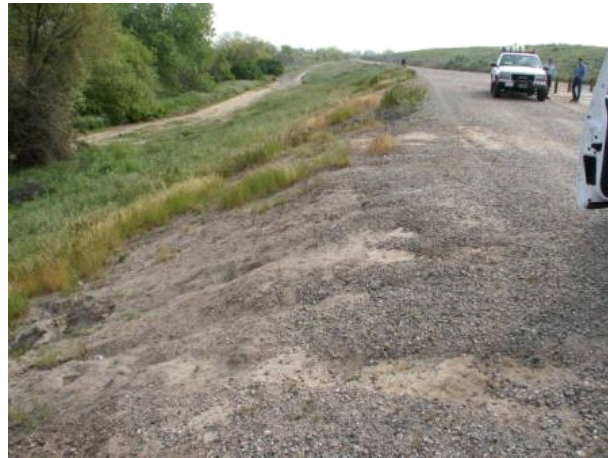
Levee Mile Report Line	15
Start Levee Mile	2.99
End Levee Mile	2.99
Location	Crown
Category	Earthen Levee
Item	Erosion / Bank Caving
04/14/2011 Erosion caused by runoff from adjacent parking lot.	
jeto_s_20110414_418.jpg

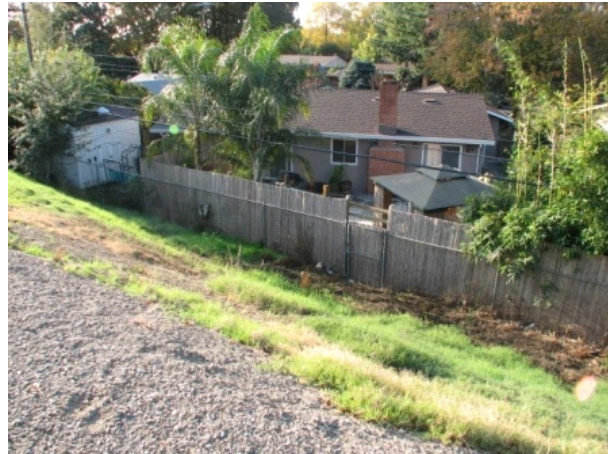
Levee Mile Report Line	18
Start Levee Mile	3.88
End Levee Mile	3.88
Location	Land Side
Category	Earthen Levee
Item	Encroachments
Fall 2009 photo: Fence and landscaping within 10-ft of levee toe obstructs access and visibility.	
jeto_s_20110301_308.jpg

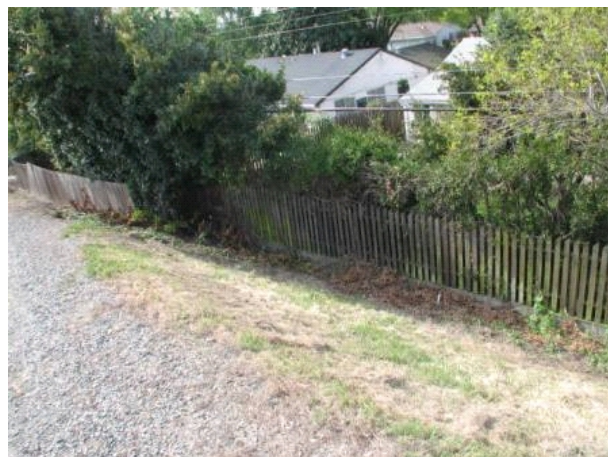
Levee Mile Report Line	20
Start Levee Mile	3.90
End Levee Mile	3.90
Location	Land Side
Category	Earthen Levee
Item	Encroachments
04/14/2011 Landscaping, which was a Fall inspection issue has been removed.	
jeto_s_20110414_419.jpg

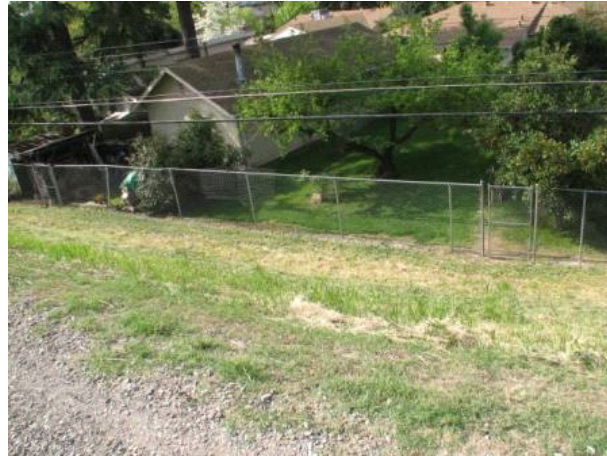
Levee Mile Report Line	45
Start Levee Mile	4.27
End Levee Mile	4.27
Location	Land Side
Category	Earthen Levee
Item	Encroachments
04/14/2011 Planter boxes have been removed.	
jeto_s_20110414_422.jpg

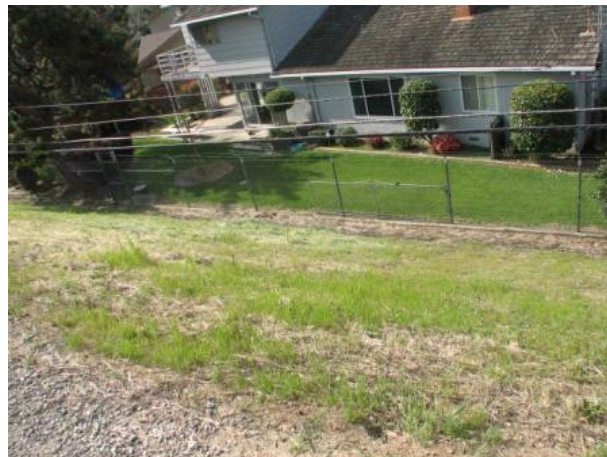
Levee Mile Report Line	48
Start Levee Mile	4.31
End Levee Mile	4.31
Location	Land Side
Category	Earthen Levee
Item	Encroachments
04/14/2011 Landscape removed, changed from CO to PO with chainlink fence.	
jeto_s_20110414_423.jpg

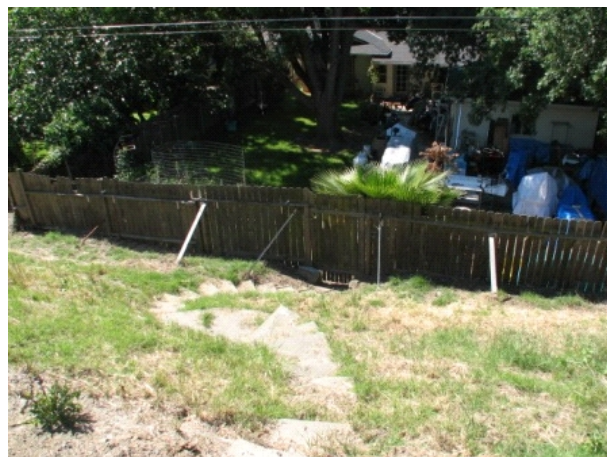
Levee Mile Report Line	80
Start Levee Mile	4.93
End Levee Mile	4.93
Location	Land Side
Category	Earthen Levee
Item	Encroachments
Wooden fence and braces obstruct access and visibility.	
jeto_s_20110301_309.jpg

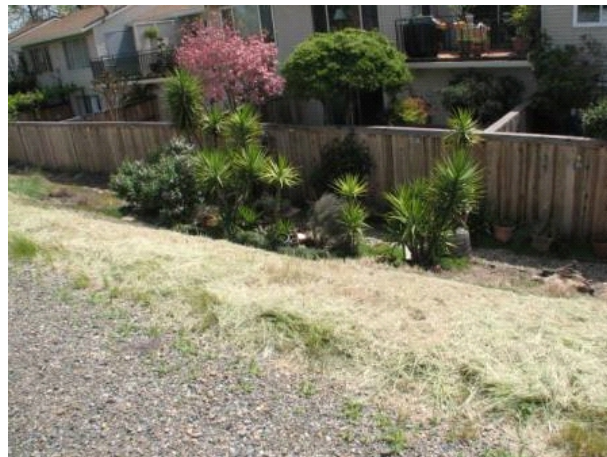
Levee Mile Report Line	125
Start Levee Mile	8.01
End Levee Mile	8.01
Location	Land Side
Category	Earthen Levee
Item	Encroachments
04/14/2011 Landscaping outside of fence on levee and wood fence completely obstruct access and visibility.	
jeto_s_20110414_425.jpg

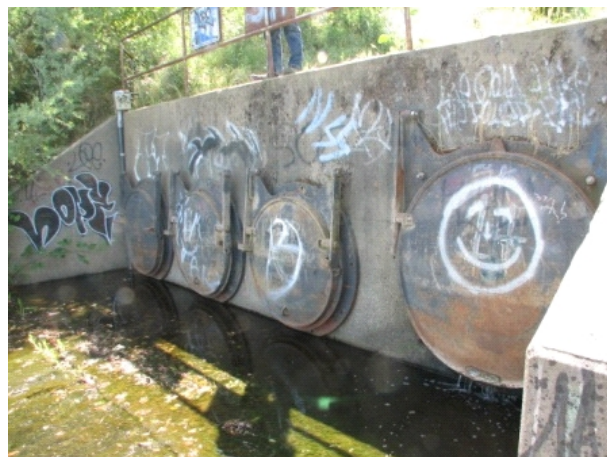
Levee Mile Report Line	172
Start Levee Mile	9.49
End Levee Mile	9.49
Location	Water Side
Category	Earthen Levee
Item	Encroachments
Drainage outfall to American River.	
jeto_s_20110301_311.jpg

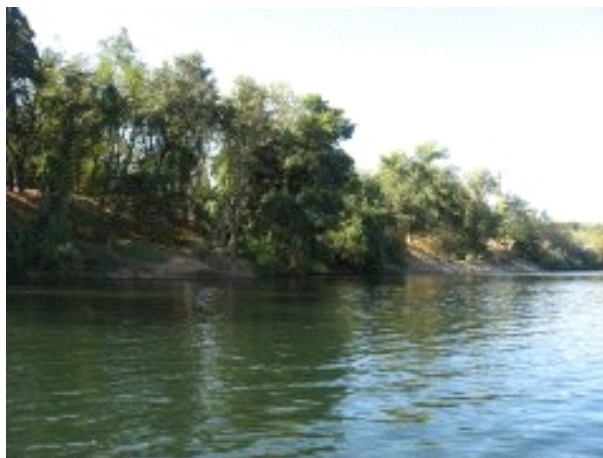
LMIR No.	Levee Mile		Category	Item	Location	Rating	Action/Comment	GPS Latitude/Longitude		Issue No. Photo
	Start	End						Start	End	
173	9.52	9.61	Supplemental	USACE Erosion Survey	WS	M	Inspector Comments: 2009: 10 ft berm, 1.5:1 slope, tree hazards, clays and silts, 8.74 ft/s [2009 SiteID:AMR_10-0_L]	38.567567 ° -121.370894 °	38.567269 ° -121.372572 °	260 Y
174	9.54	9.54	Earthen Levee	Encroachments	LS	PO	Landscaping Inspector Comments: Bushes within 10-ft of levee toe obstructs visibility.	38.566849 ° -121.372166 °	38.566849 ° -121.372166 °	120
175	9.57	9.57	Earthen Levee	Encroachments	LS	PO	Landscaping Inspector Comments: Redwoods and ivy along fence within 10-ft of levee toe.	38.566938 ° -121.371550 °	38.566938 ° -121.371550 °	237
176	9.61	9.61	Earthen Levee	Encroachments	LS	CO	Landscaping Inspector Comments: Oleander bushes and shrubs within 10-ft of landside toe.	38.567058 ° -121.370954 °	38.567058 ° -121.370954 °	121

Levee Mile Report Line	173
Start Levee Mile	9.52
End Levee Mile	9.61
Location	Water Side
Category	Supplemental
Item	USACE Erosion Survey
2009: 10 ft berm, 1.5:1 slope, tree hazards, clays and silts, 8.74 ft/s [2009 SiteID:AMR_10-0_L]	
jeto_s_20110301_314.JPG

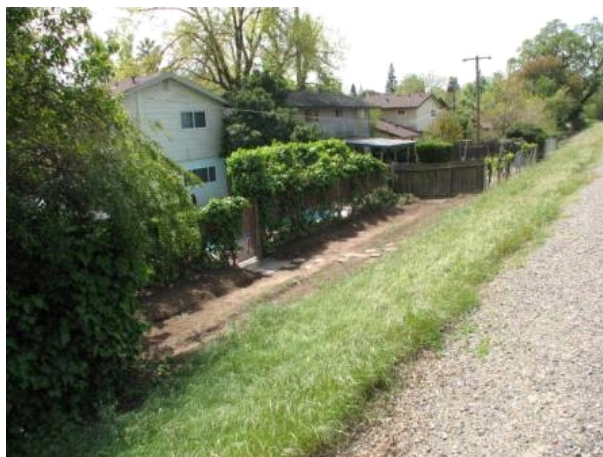
Levee Mile Report Line	192
Start Levee Mile	10.04
End Levee Mile	10.04
Location	Land Side
Category	Earthen Levee
Item	Encroachments
04/14/2011 Owner appears to be preparing ground for landscaping.	
jeto_s_20110414_426.jpg

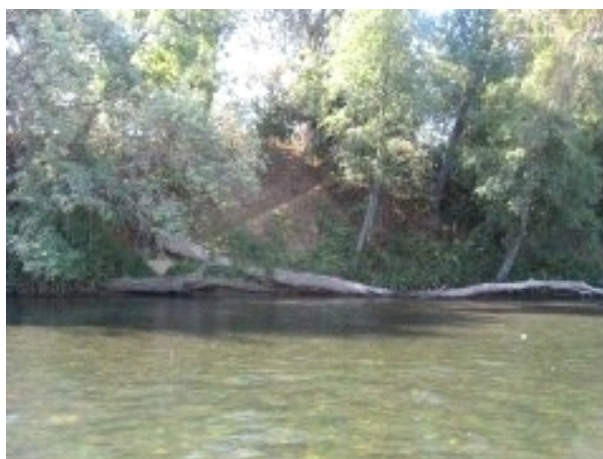
Levee Mile Report Line	199
Start Levee Mile	10.19
End Levee Mile	10.21
Location	Water Side
Category	Supplemental
Item	USACE Erosion Survey
2009: 15 ft berm, vertical slope, tree hazards and holes, clays and silts, 3.94 ft/s [2009 SiteID:AMR_10-6_L]	
jeto_s_20110301_315.JPG

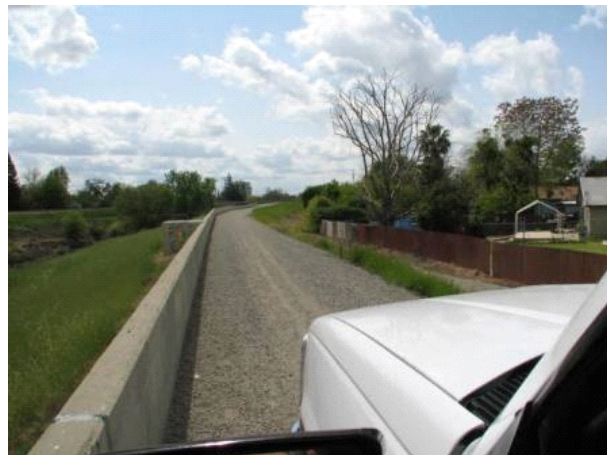
Levee Mile Report Line	5
Start Levee Mile	1.32
End Levee Mile	1.46
Location	Land Side
Category	Earthen Levee
Item	Vegetation
04/13/2011 Mowing has not yet started in this unit.	
jeto_s_20110413_407.jpg

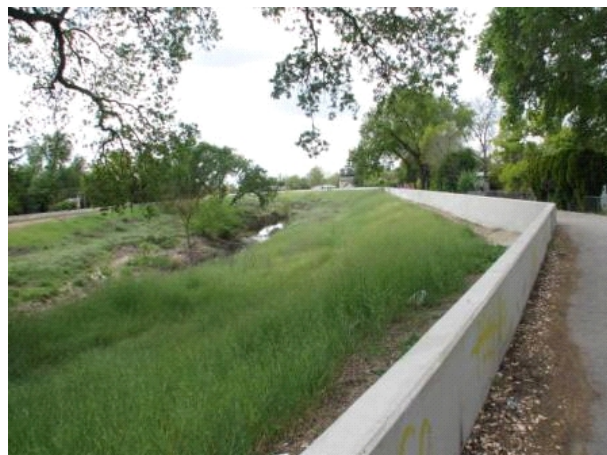
Levee Mile Report Line	6
Start Levee Mile	1.32
End Levee Mile	1.92
Location	Water Side
Category	Earthen Levee
Item	Vegetation
04/13/2011 Mowing has not yet started in this unit.	
jeto_s_20110413_405.jpg

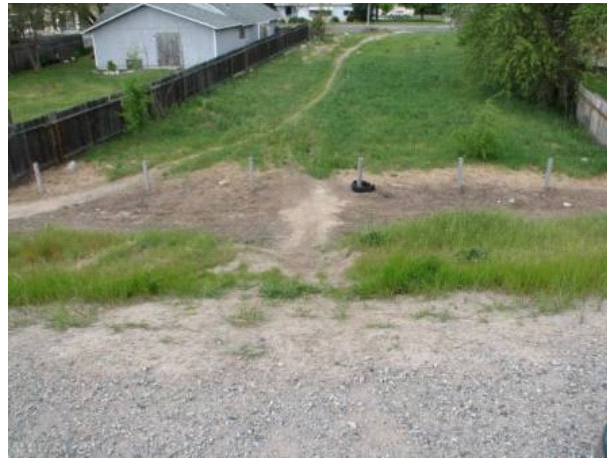
Levee Mile Report Line	7
Start Levee Mile	1.36
End Levee Mile	1.36
Location	Land Side
Category	Earthen Levee
Item	Slope Stability
04/13/2011 Damage to levee caused by foot traffic.	
jeto_s_20110413_408.jpg

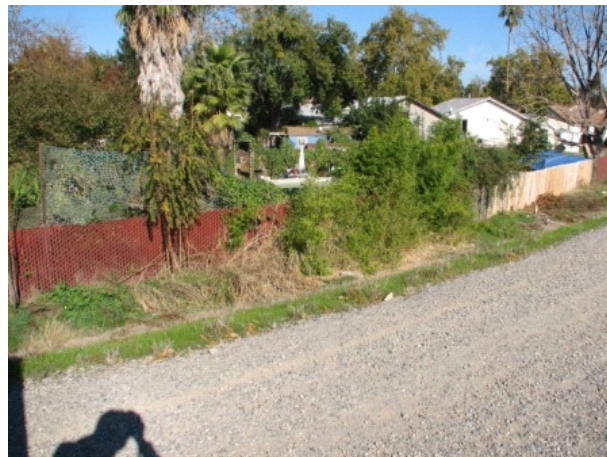
Levee Mile Report Line	8
Start Levee Mile	1.42
End Levee Mile	1.42
Location	Land Side
Category	Earthen Levee
Item	Encroachments
Fall 2009 photo of landscaping adjacent to lower levee patrol road obstructs visibility and access.	
jeto_s_20110301_323.jpg

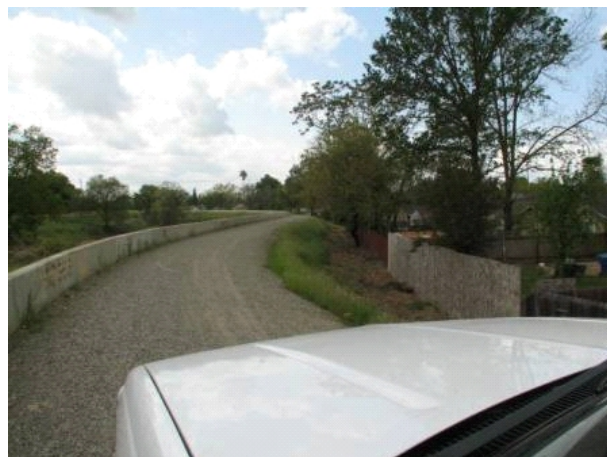
Levee Mile Report Line	13
Start Levee Mile	1.57
End Levee Mile	1.63
Location	Land Side
Category	Earthen Levee
Item	Vegetation
04/13/2011 Mowing has not yet started in this unit.	
jeto_s_20110413_406.jpg
